## INVENTORY FORM FOR STATE HISTORIC SITES SURVEY

| HISTORIC | | il ire | 8 | |
|--|--|--|---|---|
| STREET & NUMBER | 802-12,840-44,841,843 | ,845,846,848,850,852,85 | | Wes1<br>∧Fairmount Aw |

B-4567

## 8 SIGNIFICANCE

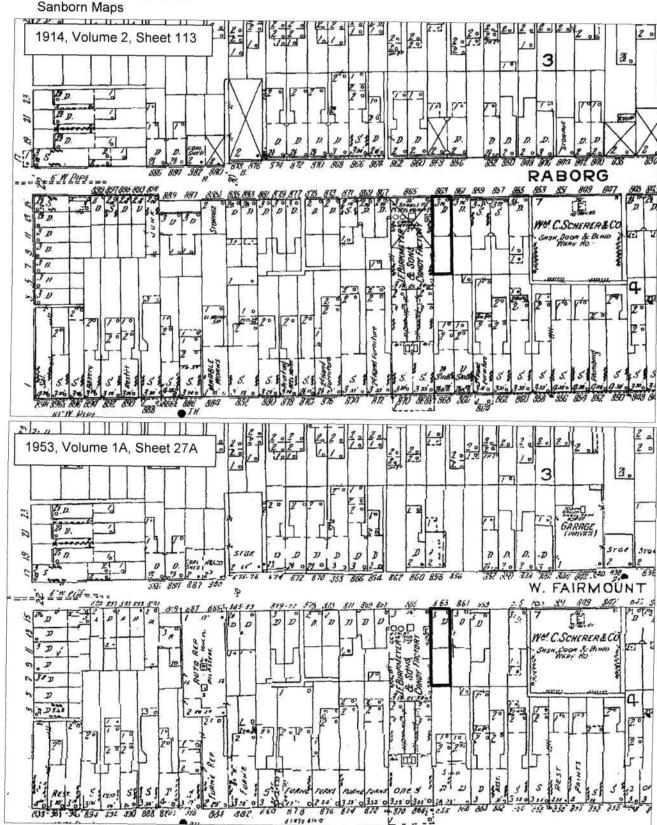
B-4067 863 W. Fairmount Avenue Block 0203 Baltimore City Baltimore West Quad

863 Fairmount Avenue is a three storey, four bay building. .It is laid in American common bond with headers every seventh row. The shed roof slopes forward. At the first storey level there are two garage doors. Each door has a row of header bond above it. The windows of the second and third stories have six-over-six lights and stone sills. The windows of the second storey have arched lintels of stretcher bond. Windows of the third story have flat lintels.

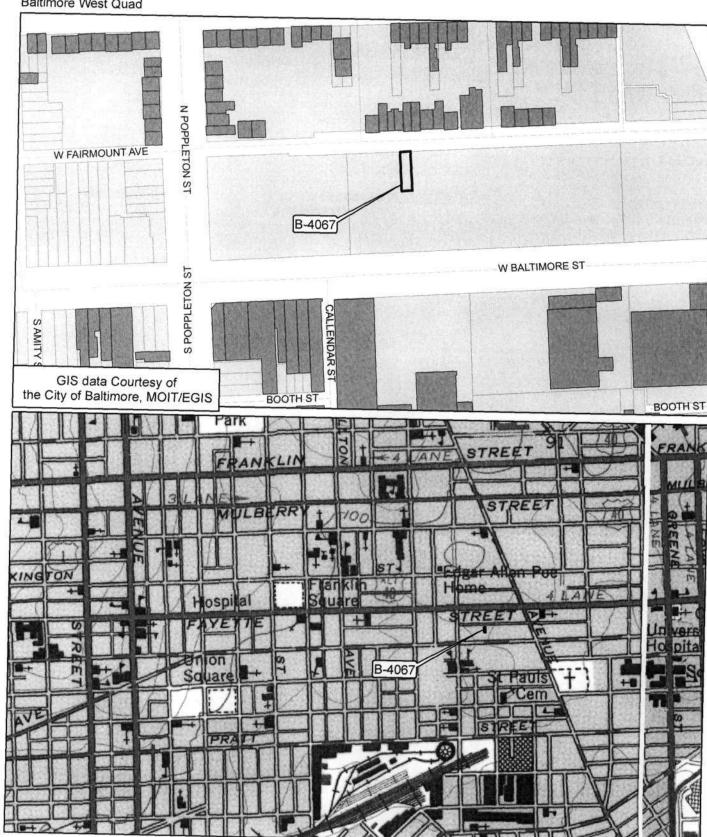
841 W. Frirmount Avenue

841,843 and 845 Fairmount Avenue are three rowhouses, built of stretcher bond brick. They are two-and-a-half stories tall and two bays wide. Some of their elements suggest the Greek revival style. The foremost of these are the eyebrow windows of three-over-three lights just beneath the low gabled roof. The first and second story windows of 841 have six-over-one lights and those of 843 and 845 have one-over-one lights. A square window is located in the basement level of each building. All the windows have flat wooden sills and lintels. All three buildings have single-leaf doors with flat-topped transoms. A round-arched sallyport is located between buildings 839 and 841, and 843 and 845. A string course of brick runs beneath the third story window of 843 and 845. All three buildings are in considerable disrepair but they presently appear to be inhabited.
